Spillway Rock Scour Experience and Analysis - the Australian Scene over the past Four Decades

E.F.R. Bollaert¹ and E.J. Lesleighter²

Abstract: *The challenge for spillway design over many decades has been to arrive at a design that can discharge floods of a wide-ranging magnitude without the scour of the material on and below which the spillway is founded. Typically, the material is rock; sometimes weak and poor quality rock for which various measures are applied to protect in the energy dissipation areas from scour that could lead to structural damage or failure. Sometimes the rock is strong and apparently of good quality. Nonetheless, in virtually all situations major scour has occurred. This is a world-wide experience. In Australia, those who design spillways have rightly considered the potential for scour, and rock scour. In many cases spillways have been constructed but have never been “put to the test”. Our purpose is to go some way to lift the lid on what can really happen, making reference to recent major floods in Australia along the east coast. Our paper discusses numerous spillways, where over the past four decades, damage has been appreciable or extensive, the importa

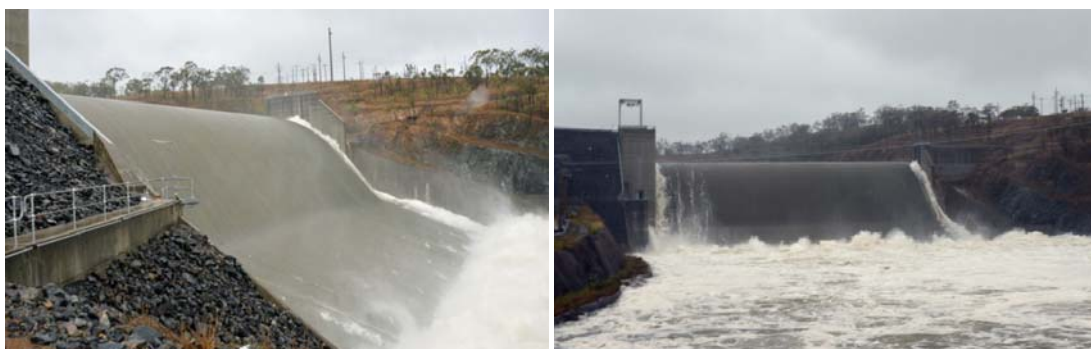
Figure 2. Views of Awoonga spillway in January 2013 flood (Photos: Gladstone Area Water Board)

Awoonga Dam is a concrete-faced rockfill dam on the Boyne River, Queensland. It is 55 m tall, the spillway crest level is EL 40 and the crest length 111 m. It has a saddle dam with a top elevation of EL47.9 m. In January 2013 the Awoonga Dam spillway experienced an overtopping head of 8.3 m (reservoir level EL 48.3 m). Hydrologic data indicate that the AEP 1 in 1,000 and 1 in 2,000 peak levels are approximately EL 47.8 m and EL 48.4 m, respectively. The 2013 flood had an estimated AEP of 1 in 1,800. A saddle dam was overtopped by around 0.4 m during the flood, fortunately with limited damage. The spillway, shown in flood in Figure 2, has a chute which slopes to the end where chute blocks are used to provide vertical spread to the jet. Thereafter, the flow passes over an excavated tailwater channel. It was found that rock in the spillway channel below the apron scoured over a distance of 50 m downstream with a maximum depth of approximately 3 m, but typically less than 2 m. The case is cited to illustrate that a flood as rare as the 1,800 year period cannot be dismissed as so unlikely that the structure is not called to account for discharges of such magnitude.

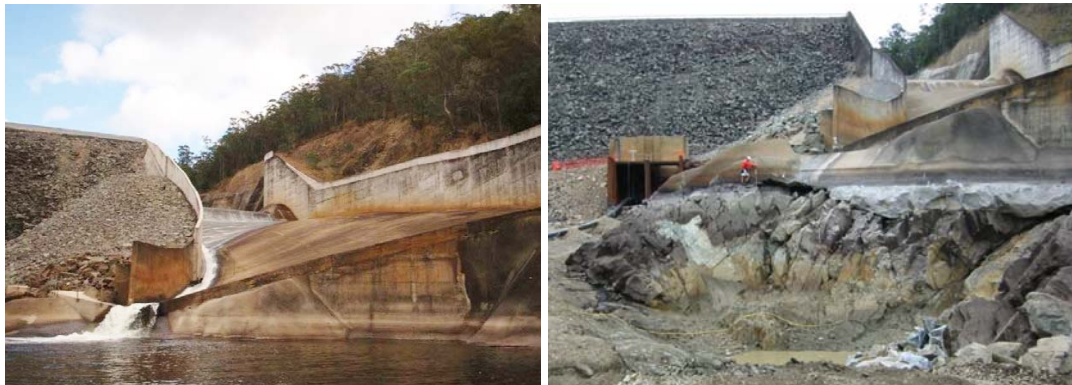
Figure 3. a) Borumba Dam spillway; b) Rock scour below spillway from 1999 flood (SEQWater photos)

Borumba Dam was built on Yabba Creek a tributary of the Mary River in Queensland in the early 1960s. It is a concrete-faced earth and rockfill embankment with a spillway in the left abutment. The spillway has a 101 m long ogee crest with flow into a partly side-channel configuration. The chute is super-elevated and follows a curved alignment to the discharge point, where the discharges flow into a plunge zone bounded by natural material, largely rock which has been described as “highly fractured slate, phyllite, quartzite, breccia and greenstone” (SunWater report, 2001). The rock was of low strength with defect spacing based on one drill hole of around 30 mm and the RQD value essentially zero. In February 1999, a flood reported to have an AEP of approximately 1 in 100, with a peak discharge of approximately 1,800 m³/s, caused deep scour in the rock below the end of the concrete chute, down to around EL 98, 9 metres below the level of the end of the chute (SunWater, 2001). That flood produced a reservoir level of EL 141 m AHD, approximately 34 m above the level of the end of the chute. Figure 3a is a view of the spillway looking up the super-elevated chute. Figure 3b is a view of the scour hole below and near the chute following the 1999 flood. Figure 4 shows the extent of scour farther downstream from the end of the chute, revealing a second downstream scour hole. The end of the chute is visible in the top right of the photograph.

The experiences at Borumba Dam highlight the capacity of discharges with relatively low head (less than 40 m from reservoir to tailwater levels), to create deep scour in the presence of concentrated flows and intense eddy action. The complex planform geometry causes a concentration of flow to the right hand side due to the curved spillway chute geometry. The character of the erosion and the likely flow pattern indicates a strong back flow below the jet exiting the chute, a mechanism which is addressed in the Quasi-Steady Impulsion (QSI) module of Bollaert's Comprehensive Scour Model.

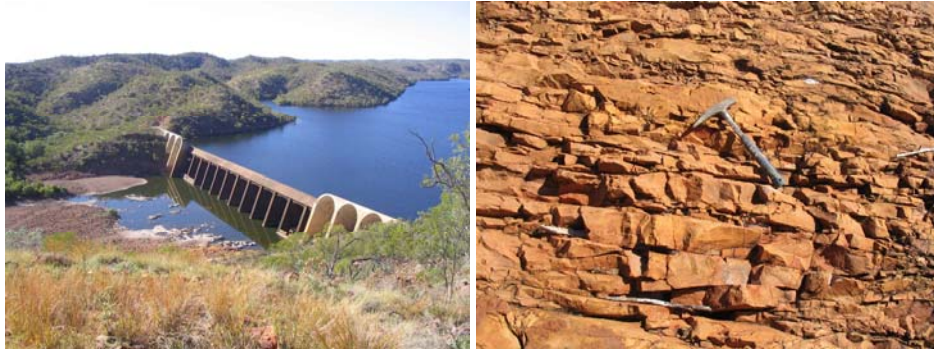
Figure 6. a) Overview of dam spillway; b) Fragmented quartzite downstream of dissipator pad

Julius Dam is a 38 m high concrete barrel-arch buttress dam on the Leichhardt River in north-western Queensland. It has an overfall spillway with flow over a crest above 12 of the barrels at EL 223.54. The spillway section is 219.46 m long. The flow over the spillway section free falls onto a concrete “dissipater pad” beyond which the river bed is composed of hard rock. Following flood discharges over the spillway in 1997, with a maximum discharge of 4,900 m³/s, remedial work downstream of the dissipater pad and along the retaining wall section on each side of the spillway was required. Figure 6a is a general view of the dam. The geology information describes the dam site as being located in quartzite and slate. Figure 6b shows the highly fragmented quartzite just downstream of the dissipater pad. Potential for further damaging rock scour was considered using both the Annandale erodibility index procedure (Annandale, 1995), and the Comprehensive Scour Model of Bollaert (2004, 2012). The work was published (Lesleighter & Bollaert, 2008) and is summarised in here.

The erodibility index procedure was applied for two key discharges – the AEP 1 in 10,000 and the Probable Maximum Precipitation Design Flood (PMPDF) discharge. On the basis of the geologic assessment, the various components of the erodibility index for its estimation were derived. Some of the key values were assessed - a UCS between 70 and 150, an RQD between 10 and 50, and 4 joint sets. With certain reservations about aspects of erodibility that the procedure tends to miss, the results indicated a geology that would be under major stress in the event of the extreme flooding that is now considered a legitimate likelihood in the present hydrologic context.

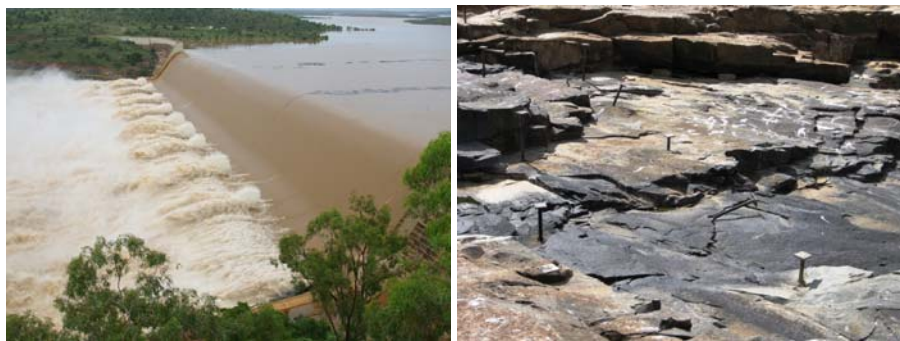
Figure 8. a) Burdekin Falls spillway 2009 flood with 6.65 m head; b) Exposed anchors following removal of top layers of rock

The Burdekin Falls Dam is a concrete gravity dam with a 504 m long overflow spillway. A general view is shown in Figure 8a. The crest level is EL 154 and the average apron level is EL 121. The peak-discharge overflow experience between the years 1990 and 2000 reveal a number of floods of appreciable magnitude. A large flood occurred in February 1991 when the head on the spillway was up to 6.85 m and the estimated discharge 19,196 m³/s (unit discharge q , 38 m²/s). In February 2009, another flood with a spillway head of 6.65 m occurred. The flood discharge is shown in Figure 8a. The rock had been anchored for some distance downstream of the apron. However, delamination of the rock had been experienced with the result that anchors were left exposed, as shown in Figure 8b. The rock in general is very hard with a large unconfined compressive strength (UCS), reportedly up to 380 MPa. There are sub-horizontal joints at variable spacing over virtually the whole rock body downstream of the dam. As well, there are a number of near-vertical joint sets (at least three) throughout. Investigations at different times have revealed that the rock body is highly stressed in the horizontal plane and this has been observed to cause “popping” as exposed surfaces delaminate.

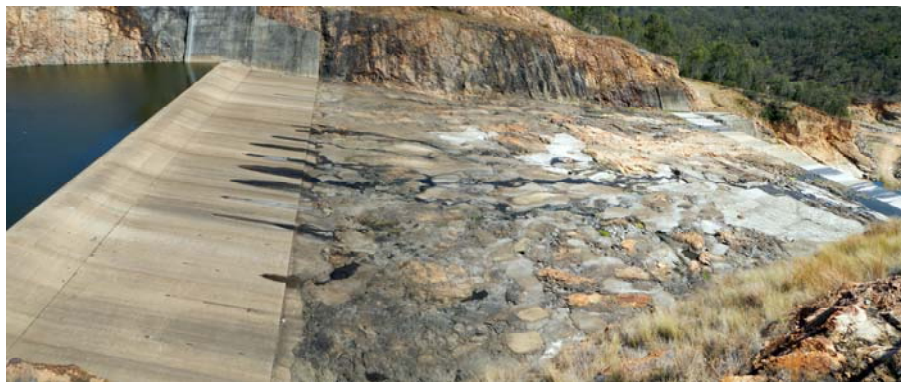
Figure 10. Boondooma Dam spillway crest and unlined spillway channel

Boondooma Dam is a 570m long, 63m high concrete faced rockfill embankment dam on the Boyne River, Queensland. It has an uncontrolled unlined spillway excavated in rock on the left abutment. The unlined chute of the spillway channel has a concrete erosion control structure at the downstream end, from which flow drops over into a plunge pool. Figure 10 shows the crest structure and the unlined chute down to the erosion control structure.

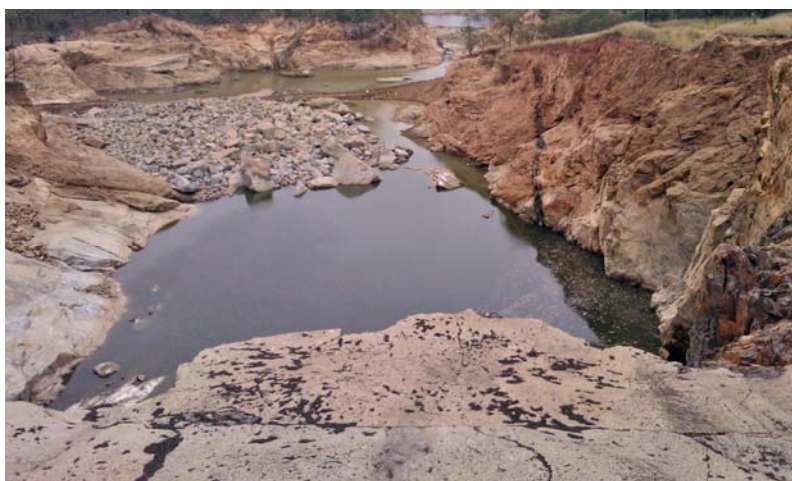
Figure 11. Boondooma spillway plunge pool below erosion control structure

Significant scour below the erosion control structure was observed after a period of low to moderate discharge in the Spillway during January 2011. The peak discharge had an AEP of approximately 1 in 30 ($1,500 \text{ m}^3/\text{s}$). In January 2013 another flood peaked at about $3,500 \text{ m}^3/\text{s}$ and was assessed as being roughly the AEP 1 in 200 flood. The scour in the plunge zone below the erosion control structure was again considerable. The extent of the main scour is shown in Figure 11 as viewed from the erosion control structure. The plunge pool increased appreciably in its pool surface area. One aspect of the scour is the occurrence of backflow below the main jet which led to some regression of the rock face below the erosion control structure.
